SUMMARY TRIP REPORT AND PHOTOGRAPHS

**Visual Site Inspection
Photograph Log
January 6, 1992**

**Mobil Chemical Company
Temple, Texas**

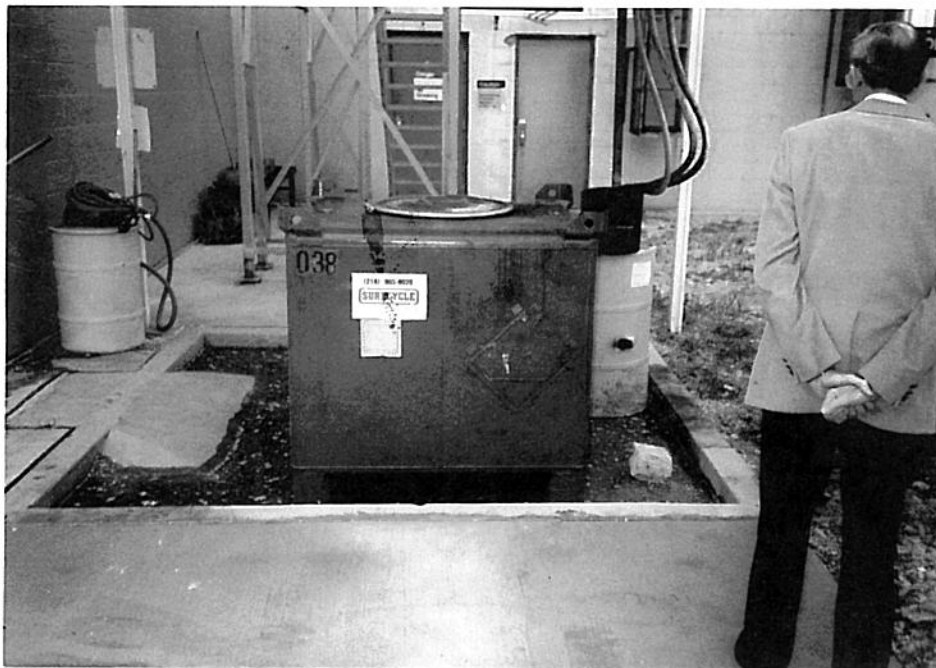
- 35 01-06-92, 12:35 p.m. View to the north. Outside Foam plant Pentane Reclaim Department. Hazardous Waste Accumulation Area (SWMU #20). Water in bermed area is rain water containing pieces of polystyrene resin. Photo taken by Michael Lanz.

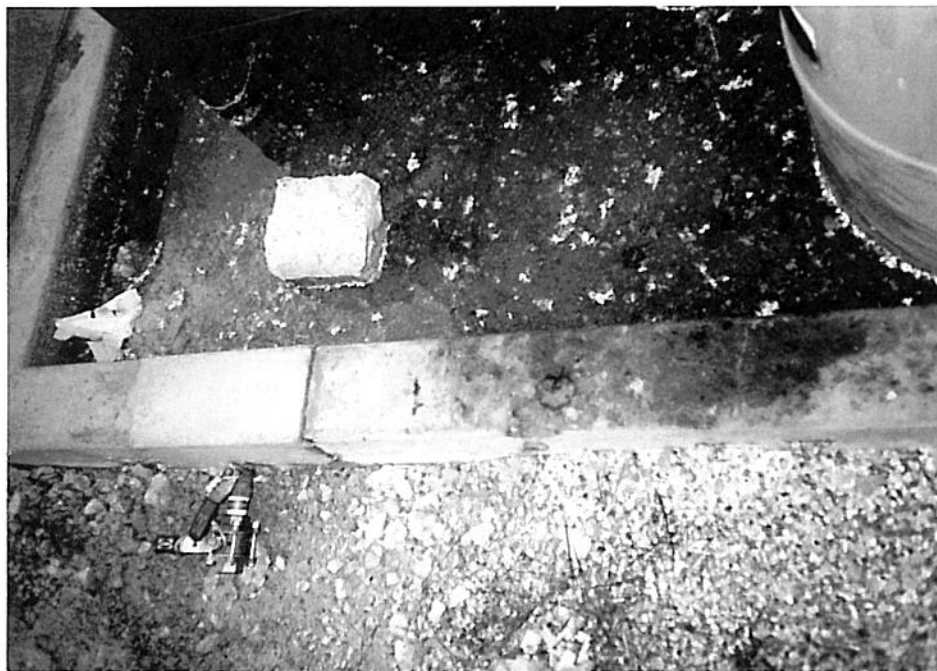
- 36 01-06-92, 12:37 p.m. View facing west. Outside of Foam plant Pentane Reclaim Department. Standing rain water in bermed area of Hazardous Waste Accumulation Area (SWMU #20). Water in bermed area is rainwater. Photo taken by Michael Lanz.

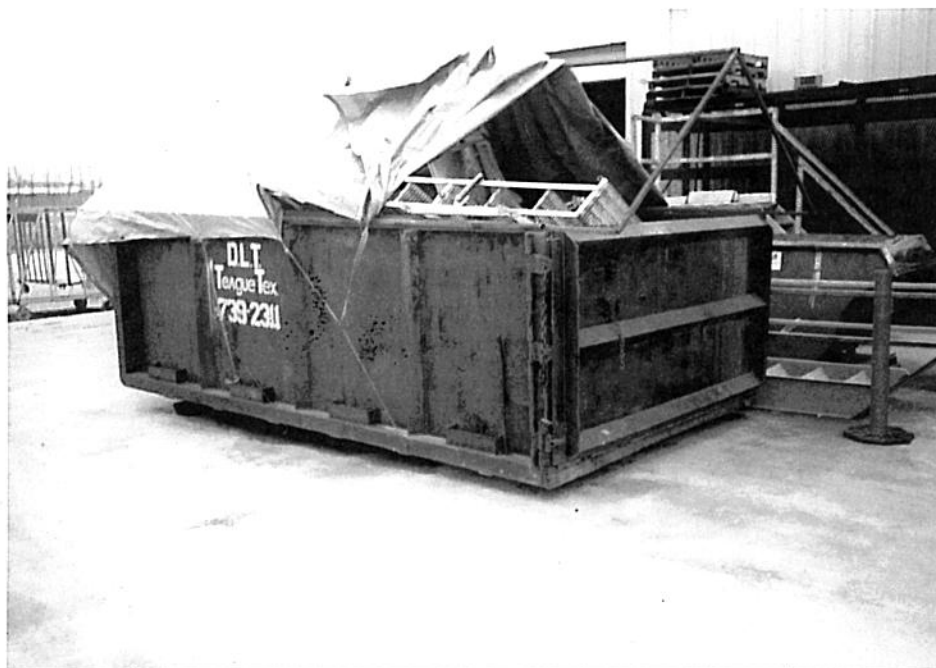
- 37 01-06-92, 12:55 p.m. View to the east. Between Foams manufacturing and the old roll storage building. 20-Cubic Yard Scrap Metal Roll-Off Container (SWMU #21). Photo taken by Michael Lanz.

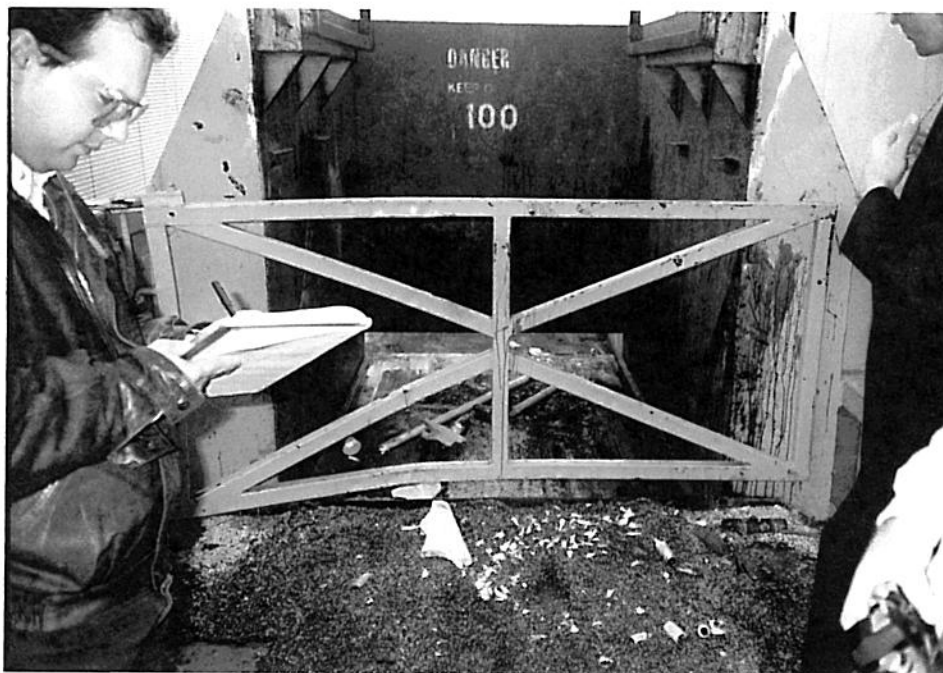
- 38 01-06-92, 12:57 p.m. View to the south. Southeast corner of Foams Warehouse. Trash Compactor of Trash Compactor/40-Cubic Yard Roll-Off Container (SWMU #22). Photo taken by Michael Lanz.

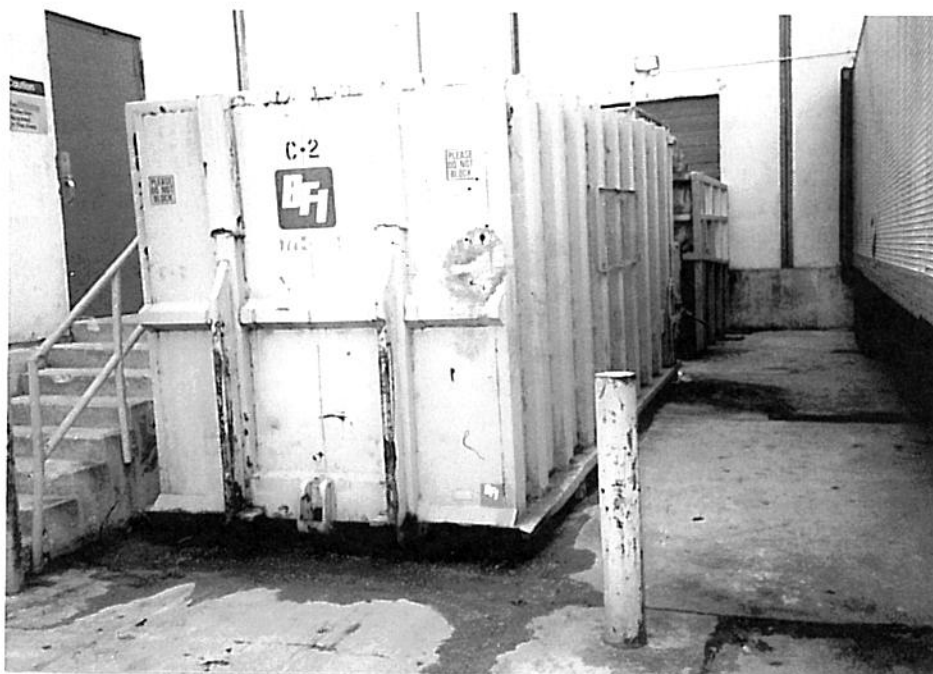
- 39 01-06-92, 12:58 p.m. View facing north. Roll-Off Container of Trash Compactor/40-Cubic Yard Roll-Off Container (SWMU #22). Photo taken by Michael Lanz.

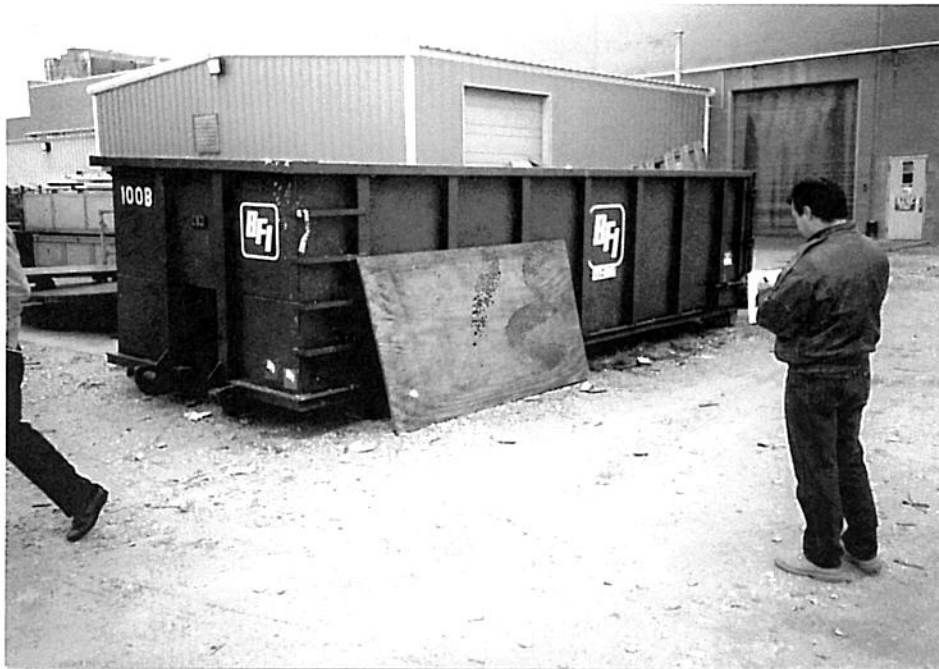
- 40 01-06-92, 12:57 p.m. View facing east. Between Foams manufacturing and old roll storage. 40-Cubic Yard Roll-Off Container (SWMU #23). Photo taken by Michael Lanz.

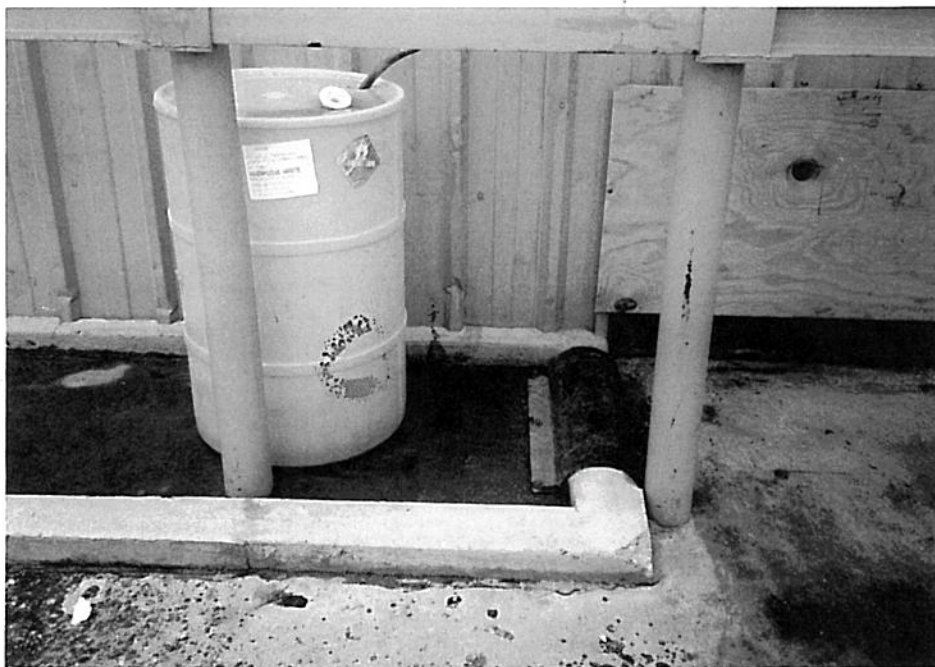
- 41 01-06-92, 1:00 p.m. View facing south. North side of the Foams manufacturing building. Satellite Accumulation Area for Polystyrene Sludge (SWMU #24). Photo taken by Michael Lanz.

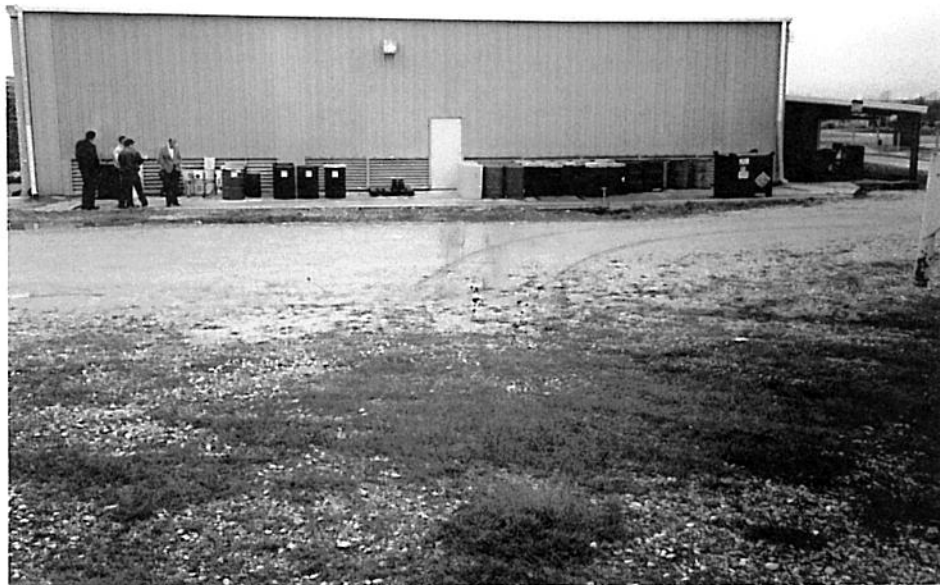
- 42 01-06-92, 1:10 p.m. View to the west. East of the old roll storage building. Drum Storage Area (SWMU #25). Photo taken by Michael Lanz.

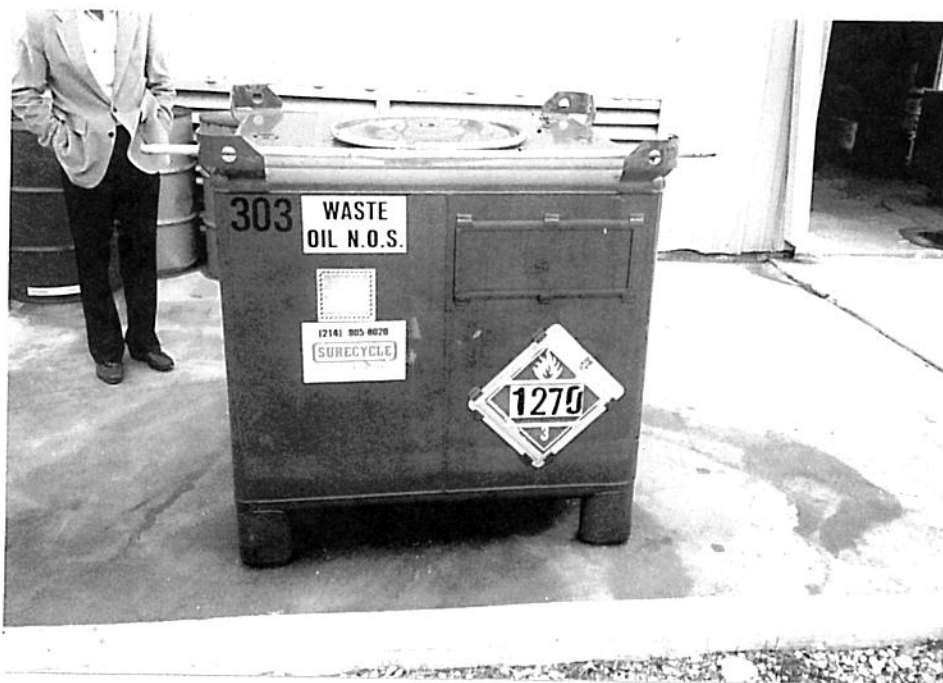
- 43 01-06-92, 1:12 p.m. View to the west. East of the old roll storage building. 340-Gallon Used Oil Tank located in Drum Storage Area (SWMU #25). Note: There is a hazardous waste label on the container, but facility representatives claim that it was mislabeled. Photo taken by Michael Lanz.

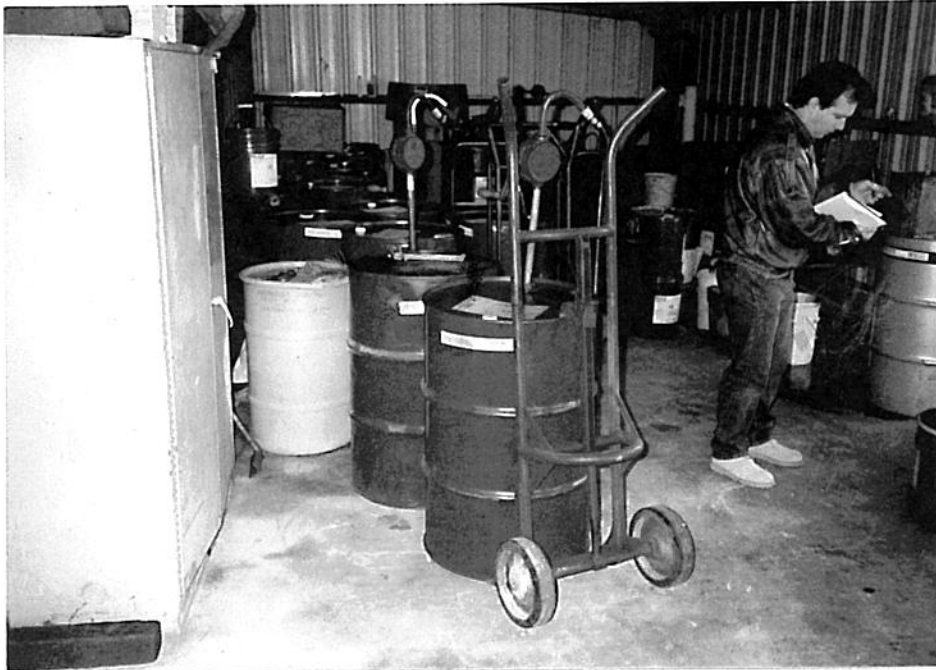
- 44 01-06-92, 1:15 p.m. View to the west. North side of old roll storage building. Hazardous Waste Container Storage Area (SWMU #26). Photo taken by Michael Lanz.

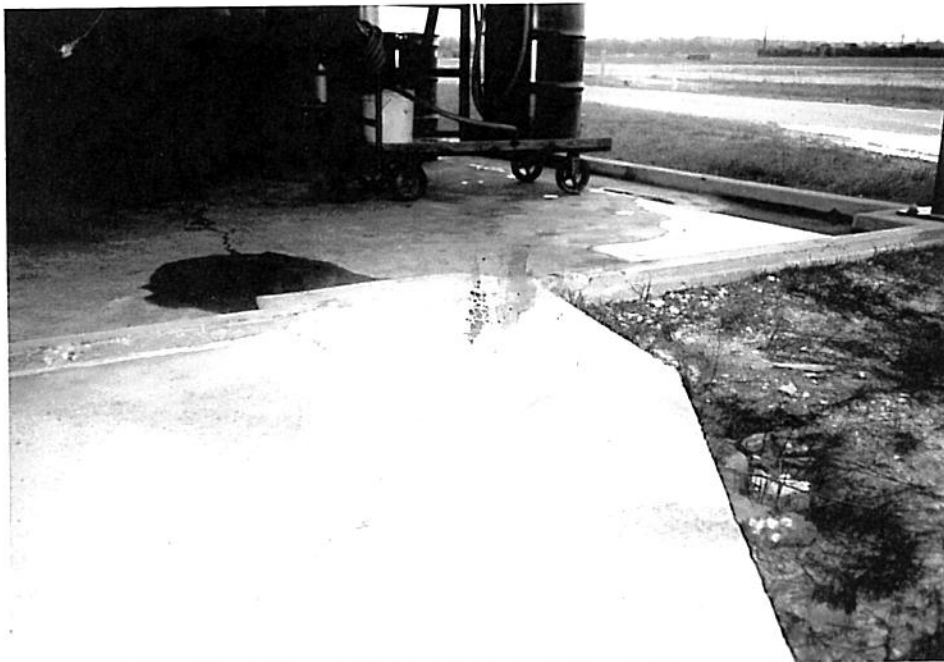
- 45 01-06-92, 1:17 p.m. View to the west. North side of old roll storage building. Bermed area around Hazardous Waste Container Storage Area (SWMU #26). Photo taken by Michael Lanz.

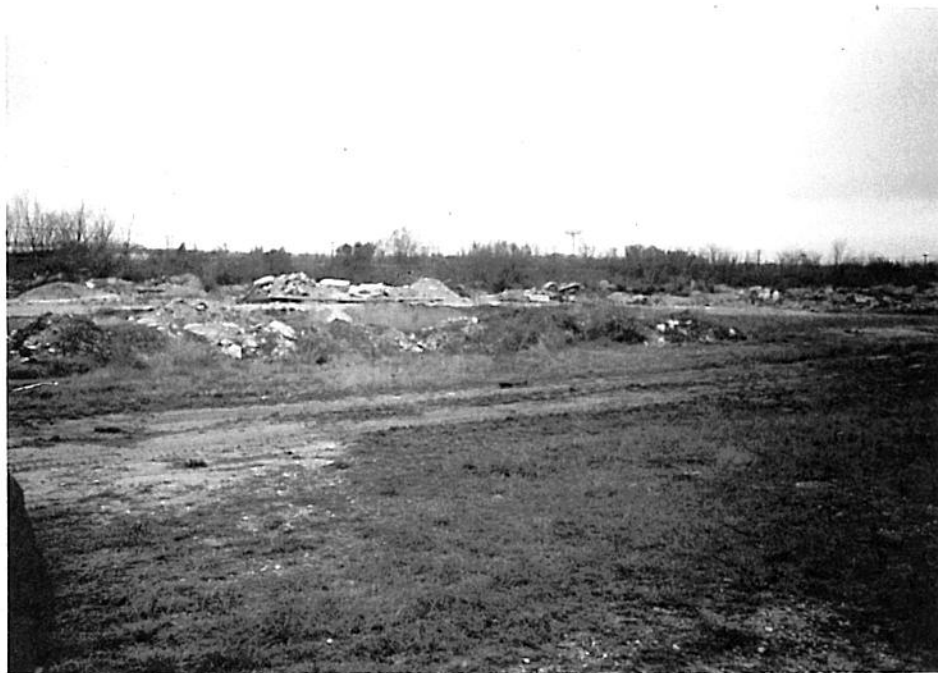
No releases to surface water have been documented at this facility. There is a potential for surface water contamination from SWMU 27. Run-off from the SWMU may enter on-site drainage ditches that lead off-site. The SWMU manages waste pea gravel that contains small amounts of naphtha, lead, and arsenic.

There is a moderate potential for ground water contamination due to infiltration and/or percolation of wastes from SWMU 27. The SWMU manages waste pea gravel that contains small amounts of naphtha, lead, and arsenic.

46 01-06-92, 1:25 p.m. View to the north. Construction Debris Pile (SWMU #27). Photo taken by Michael Lanz.

- Sandblasting Unit (SWMU No. 11) (Conditional)
- Construction Debris Accumulation Area (SWMU No. 27)

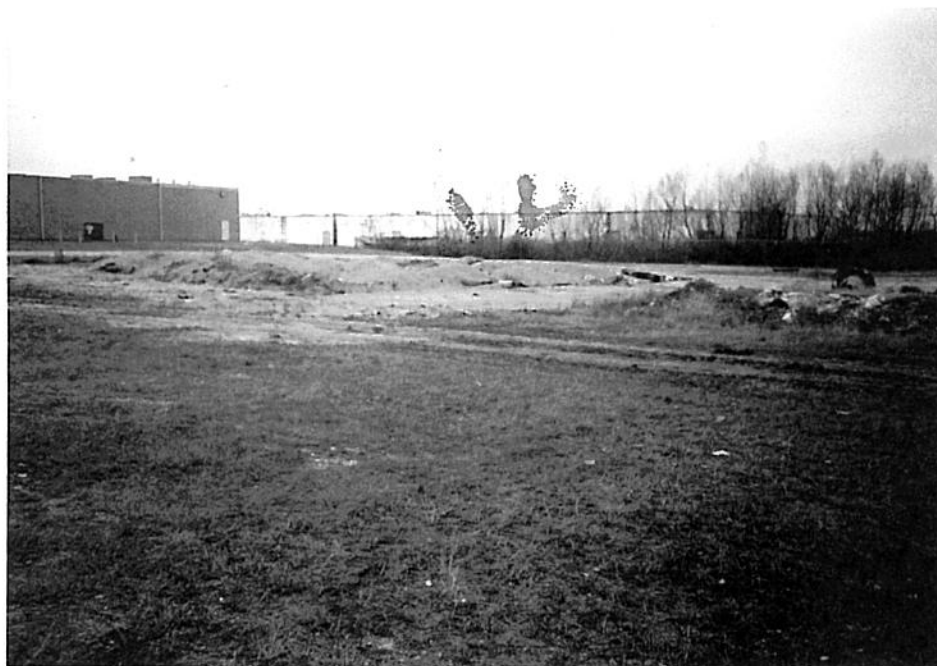
47 01-06-92, 1:27 p.m. View to the west. Construction Debris Pile (SWMU #27). Photo taken by Michael Lanz.

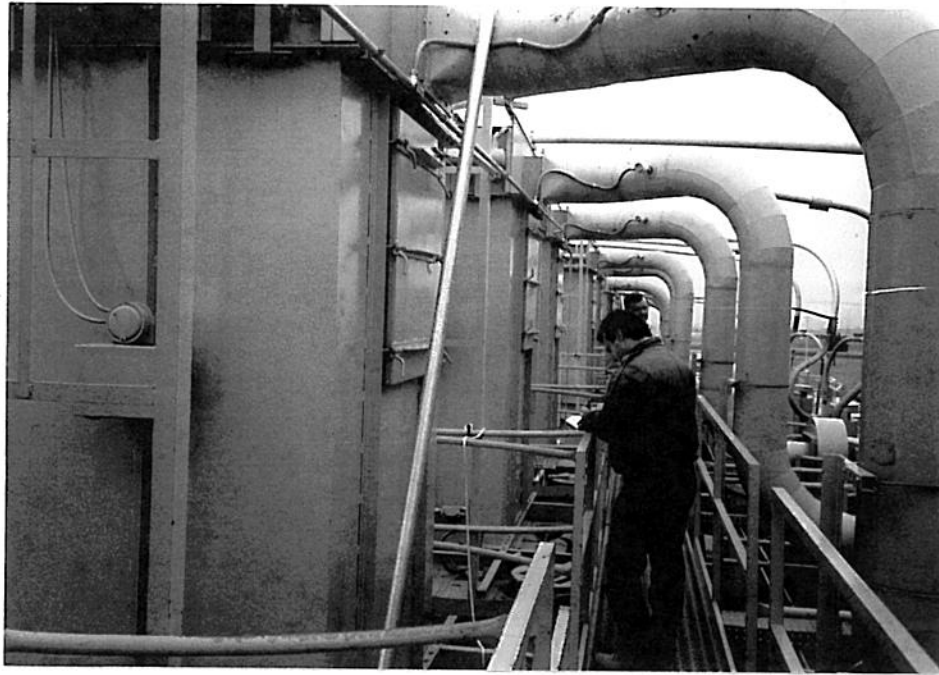
48 01-06-92, 1:45 p.m. View to the east. South side of Foams manufacturing building. Bag House Units (SWMU #28). Photo taken by Michael Lanz.

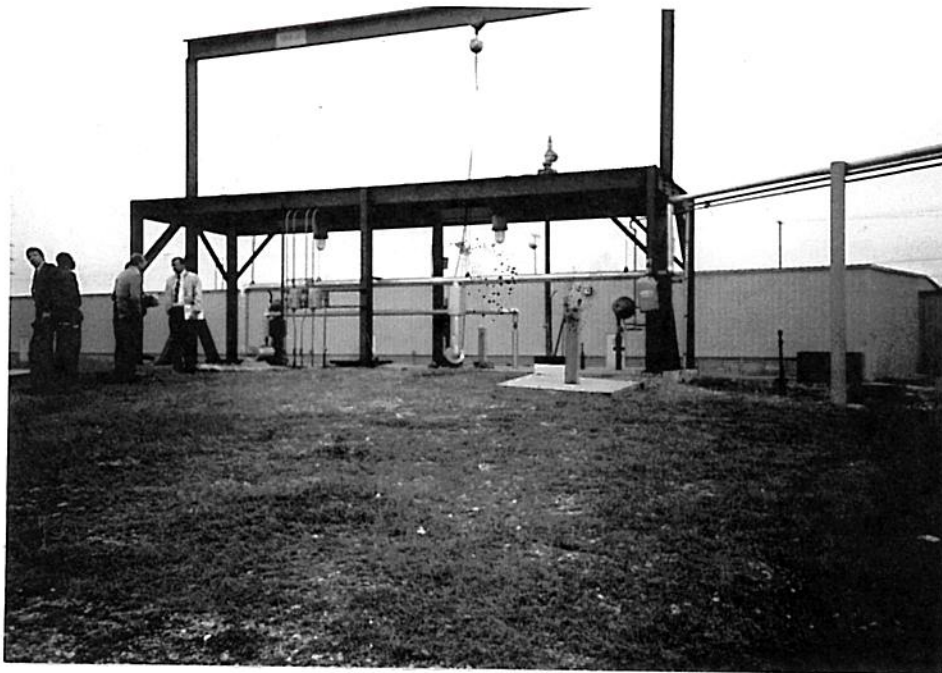
Ground-water contamination has occurred as a result of a September 1981 release of 10,000 gallons of isopentane from AOC 1. When the release was discovered, Mobil Chemical Company pumped approximately 250 55-gallon drums of contaminated ground water from the area surrounding the unit. Mobil installed a monitoring well network and monitors the ground water on a monthly basis. Analyses of ground water currently indicate concentrations of isopentane in ground water at levels from not-detected to 38 ppm. The unit is expected to be closed in June of 1992 according to an approved closure plan that is currently being drafted. There is a high potential for ground-water contamination at this unit.

49 01-06-92, 1:30 p.m. View to the east. 50,000-Gallon Isopentane Underground Storage Tank (AOC #1). Photo taken by Michael Lanz.

Need for RFI	None	Conditional - continue coordination with EPA, TWC, and the City of Temple to remediate the area and close the unit.

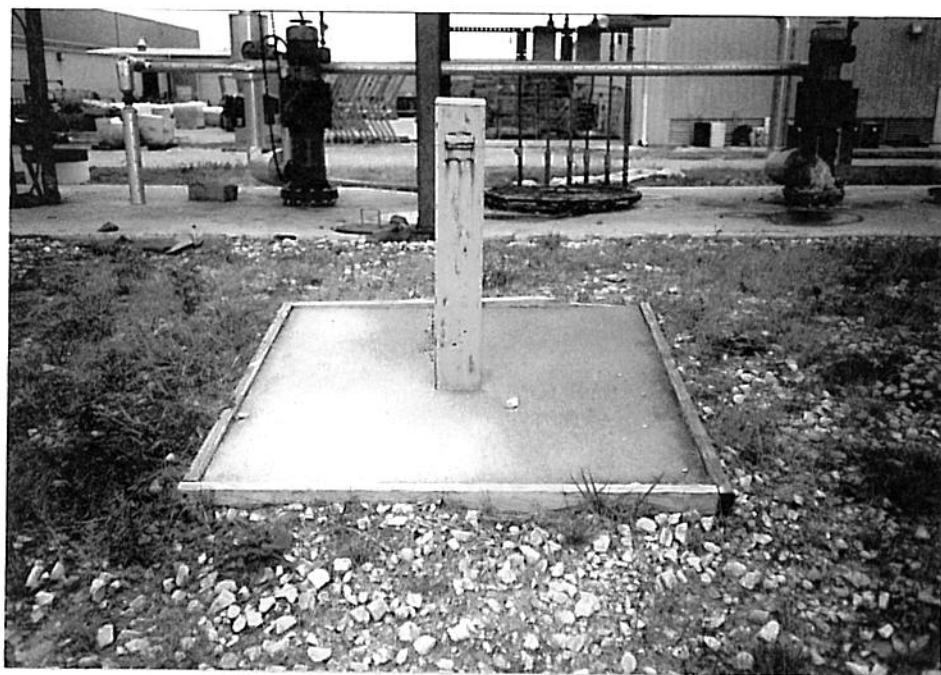
50 01-06-92, 1:32 p.m. View to the west. Monitoring Well of 50,000-Gallon Isopentane Underground Storage Tank (AOC #1).
